High Risk Excavation - Raised property retaining wall collapsing into neighbors

- Shows job step by step -

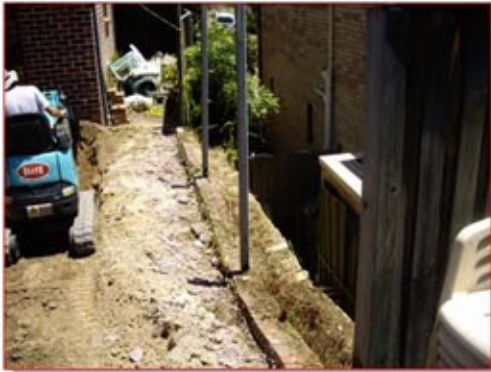
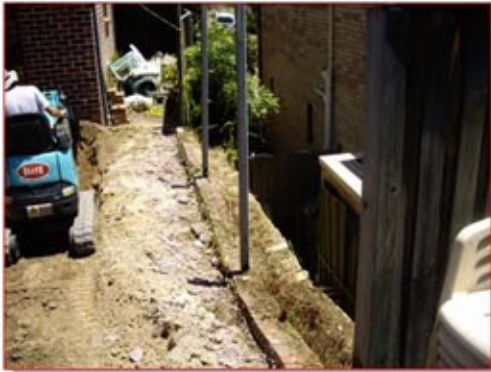
#1 Menai property- retaining wall holding up owners property collapsing onto neighbouring property 3.4 m below

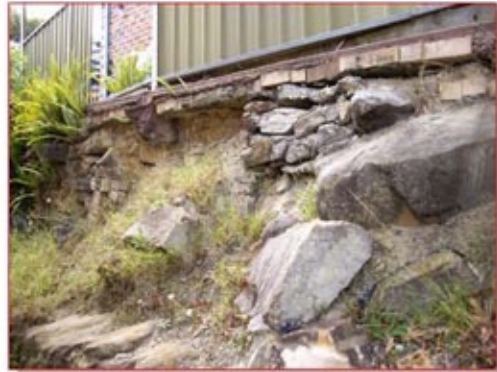
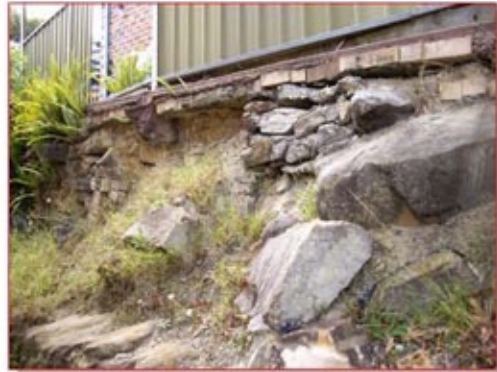
#2 Poorly constructed retaining wall collapsing into neighbors property below. Pic from below

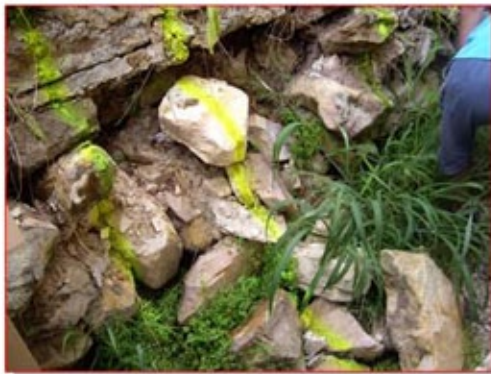
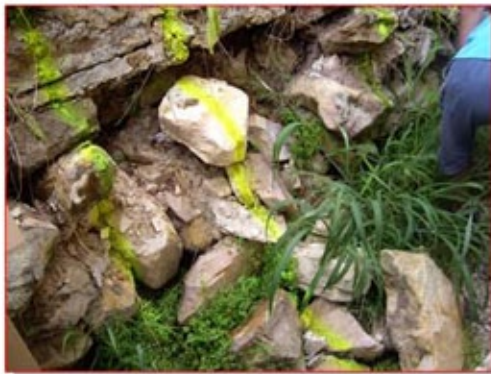
#3 Paint lines drawn by property owners to show movement of rocks in wall structure

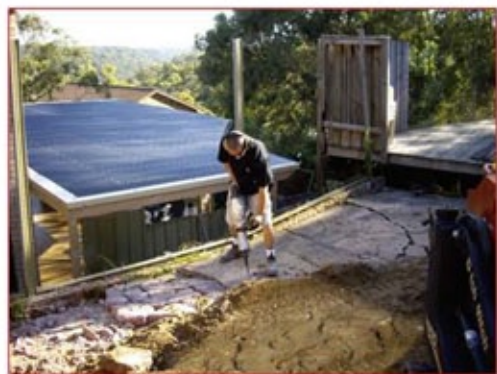
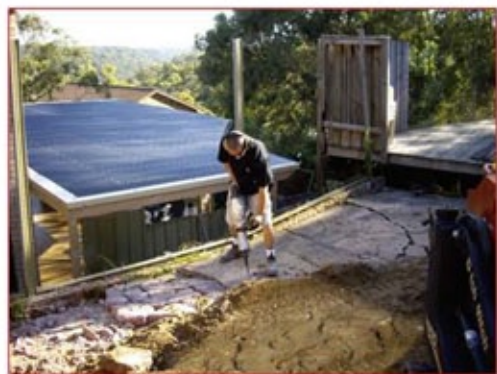
#4 Breaking up concrete by hand as edge of retaining wall not stable enough to hold machinery yet

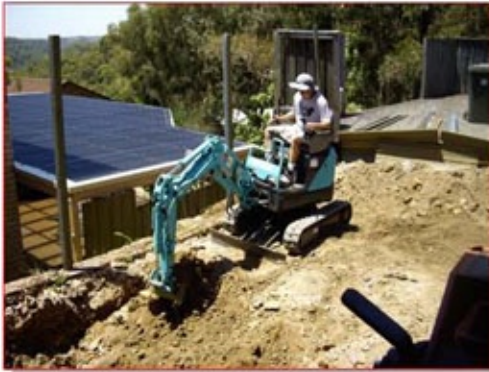
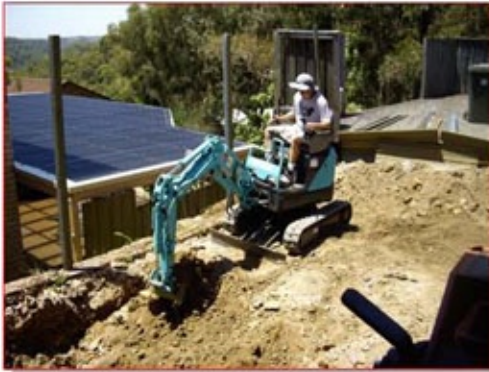
#5 Shows small space available while starting to carefully dig down with excavator while ensuring wall does not collapse

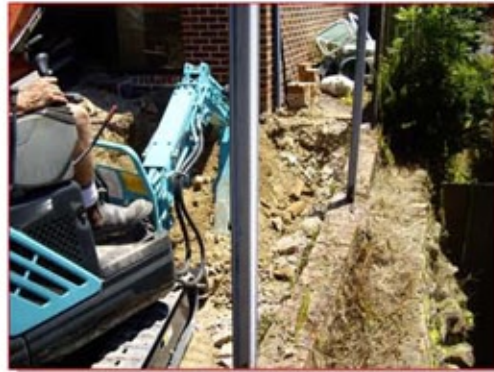
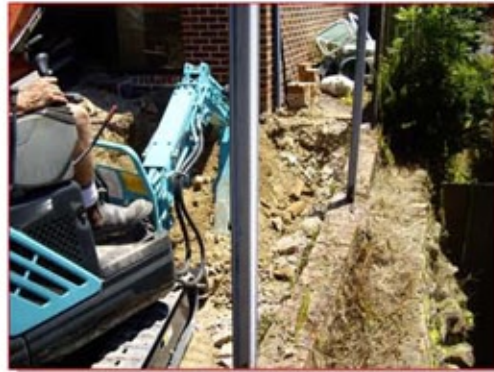
#6 Need to dig down to neighboring property height 3.4m below so retaining wall can be rebuilt safely to hold weight of owners house and yard above

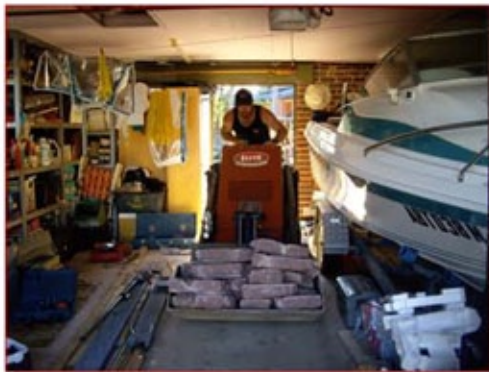
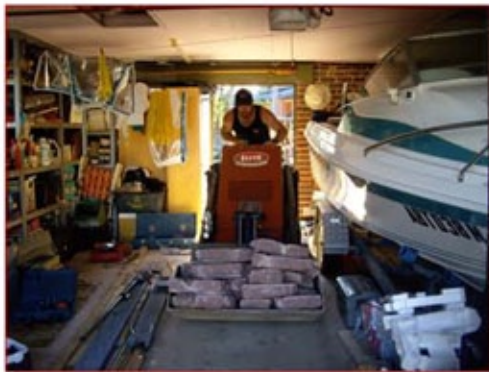
#7 Only access through owners full garage. Carefully backing through with load of broken concrete and brick

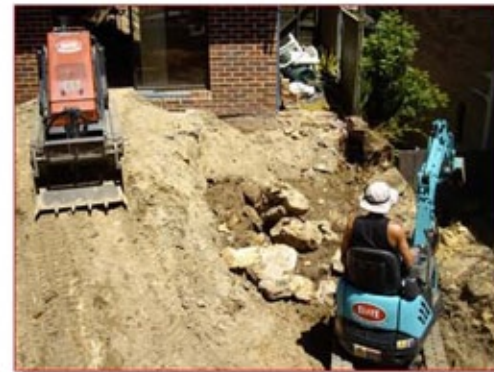
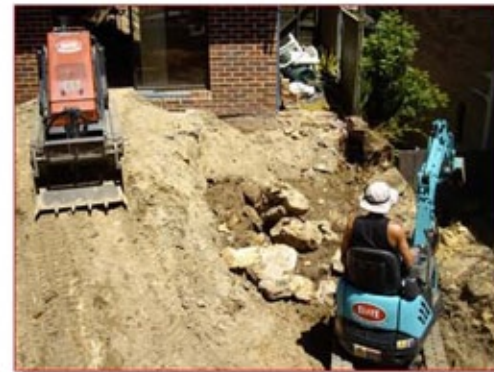
#8 Dirt ramp made from garage entry to deepening excavation. About 2m down now & carefully pulling wall in safely
